CAUSES AND CONTROL OF CONDENSATION IN
SHRINK FILM UNIT LOADS UNDER OUTDOOR
STORAGE CONDITIONS

Anderson Miller

Army Natick Laboratories
Natick, Massachusetts

75-6-FEL

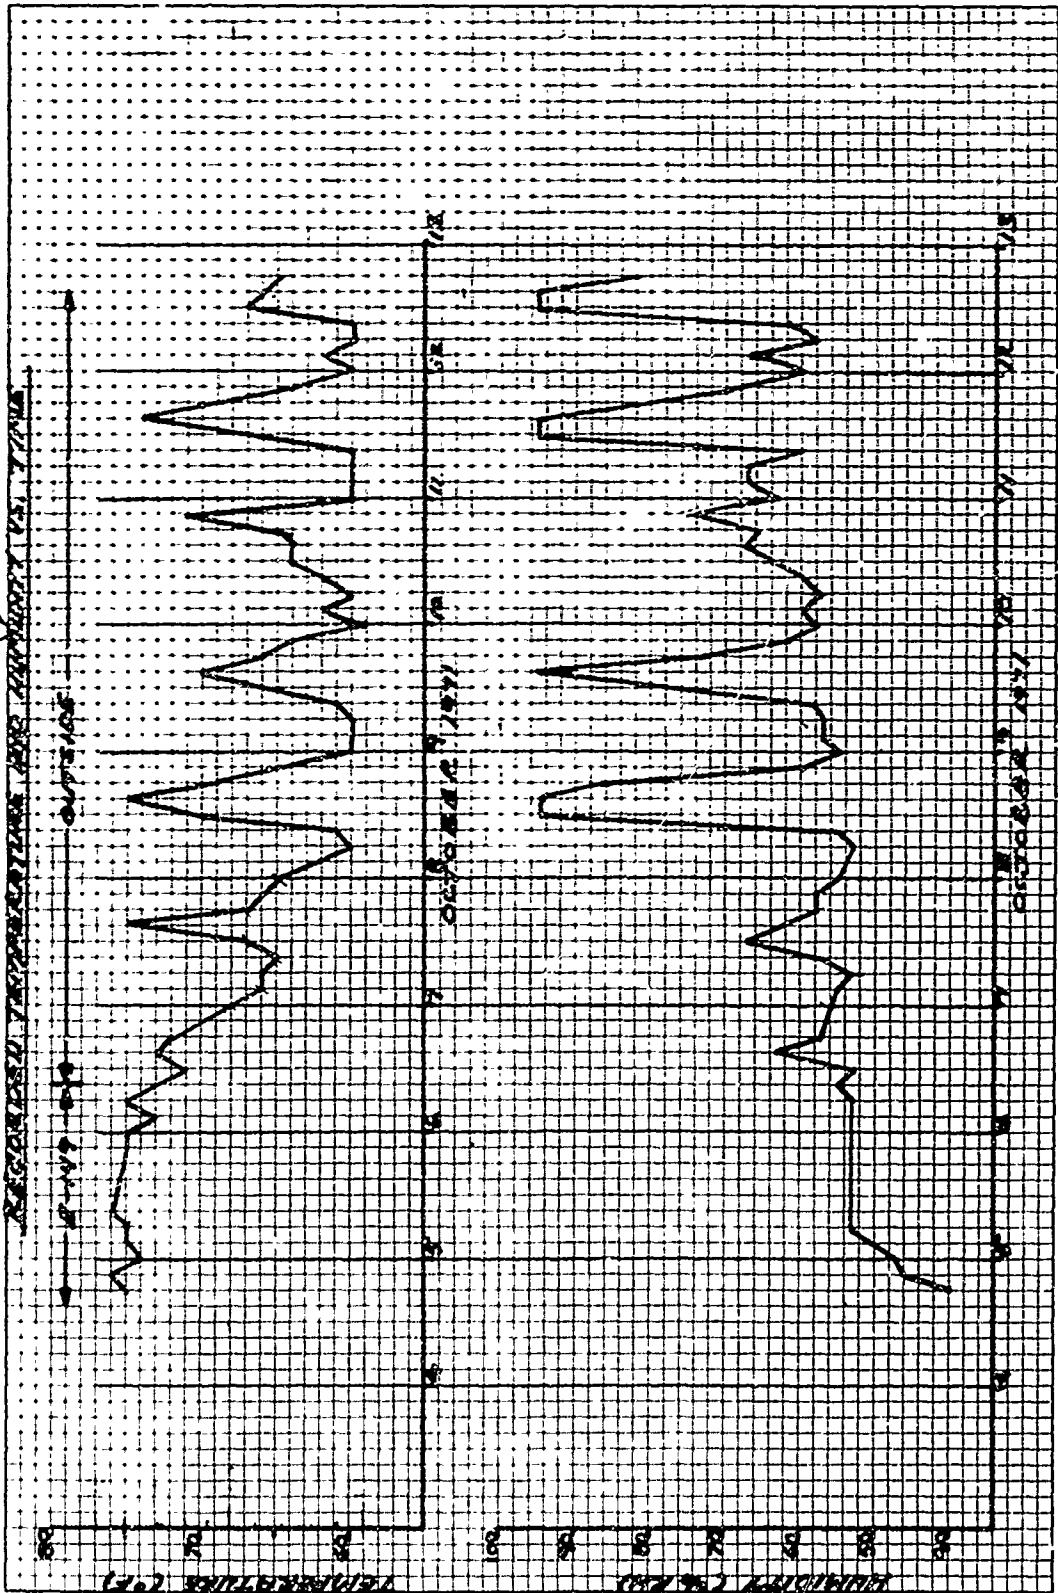
7. The results of the load instrumented with the NLABS recorder are shown in Figures 10 - 13. As noted on the curves, the 8th, 9th, 11th and 12th, which were sunny days, indicated that the humidity inside the load reached 95%, while on three rainy and humid days (6th, 7th and 10th), the indicated humidity inside the load never exceeded 75%. This was further indication that the amount of available sunlight has a more pronounced effect on the humidity level inside the shrink film unit load than the amount of available moisture in the air around the load.

FIGURE 10
 Results of the temperature-humidity recordings taken with the NIABSS Recorder. On the 8, 9, 11 and 12th, which were dry sunny days, the humidity reached 95%; whereas, on the 6, 7 and 10th, the days were rainy and humid and the humidity inside the load was much lower.

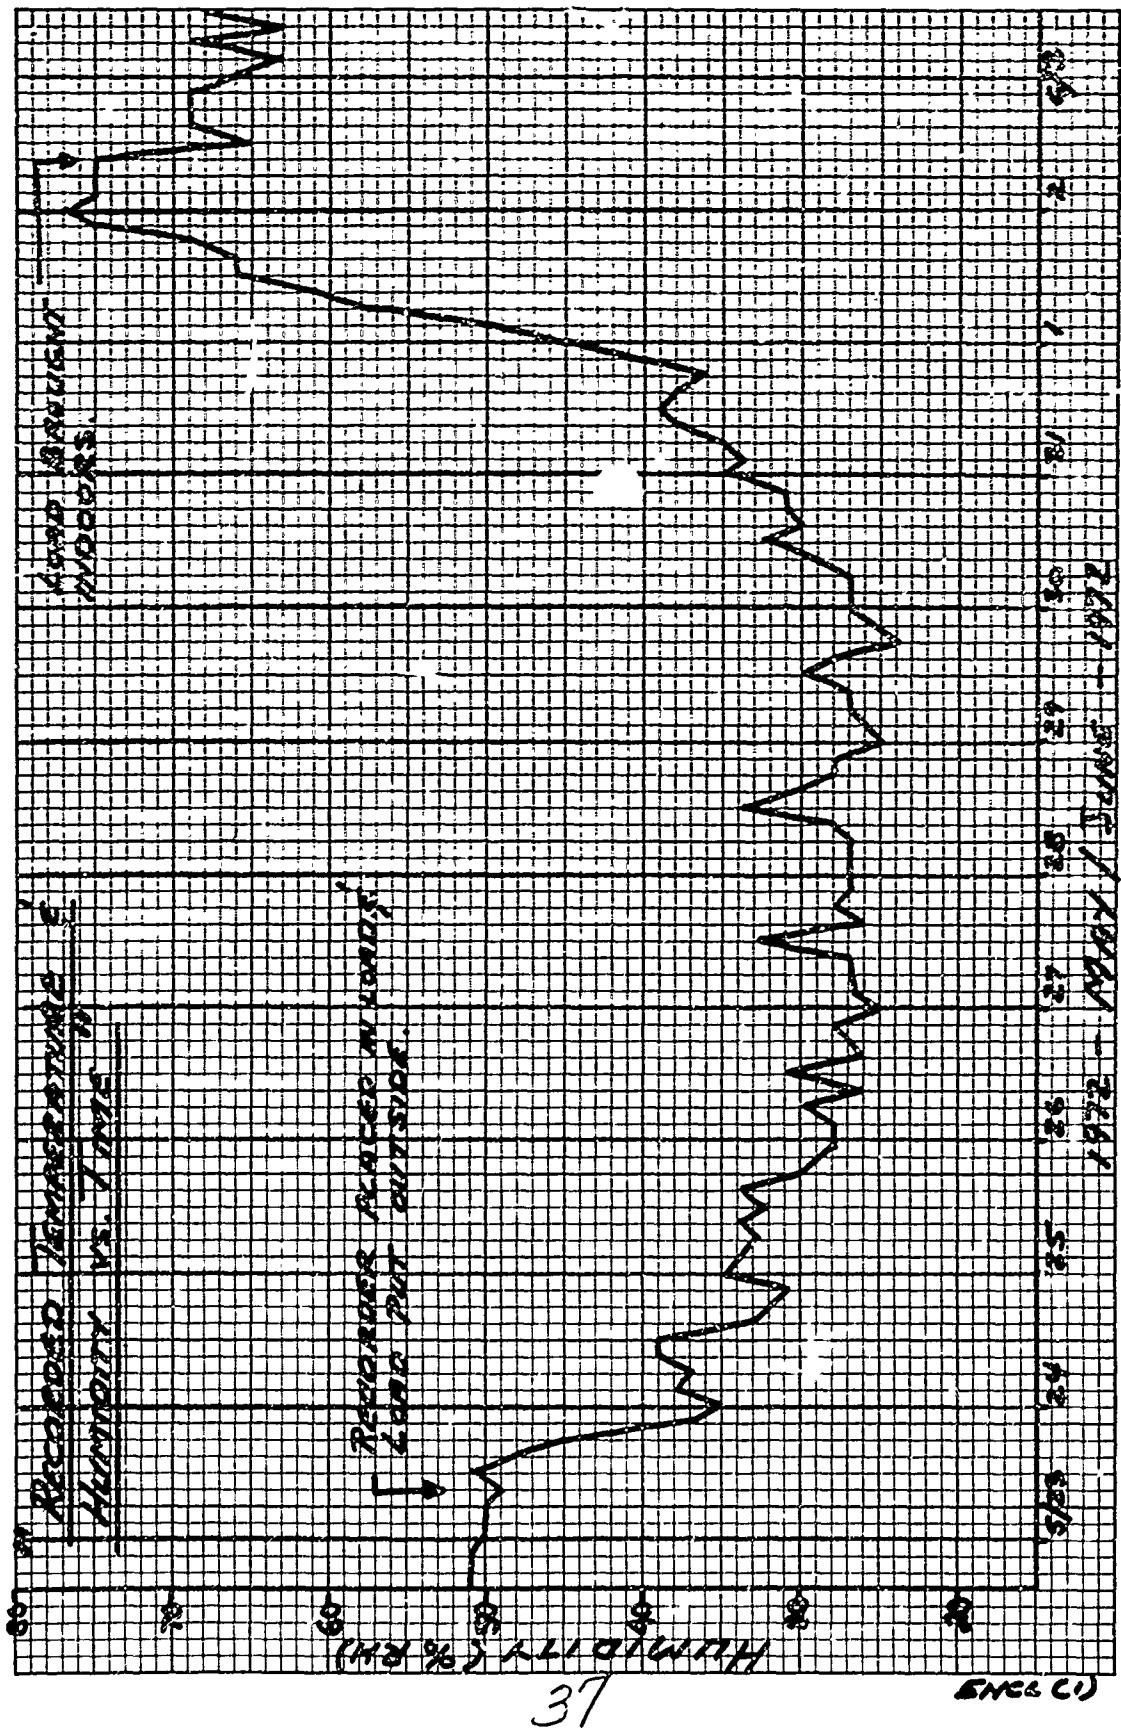
FIGURE 11

Humidity recordings of the inside of a shrink wrapped load which has been conditioned at 140°F and 10% R.H. prior to shrink wrapping. No temperature recording was made due to a malfunction in the recorder.

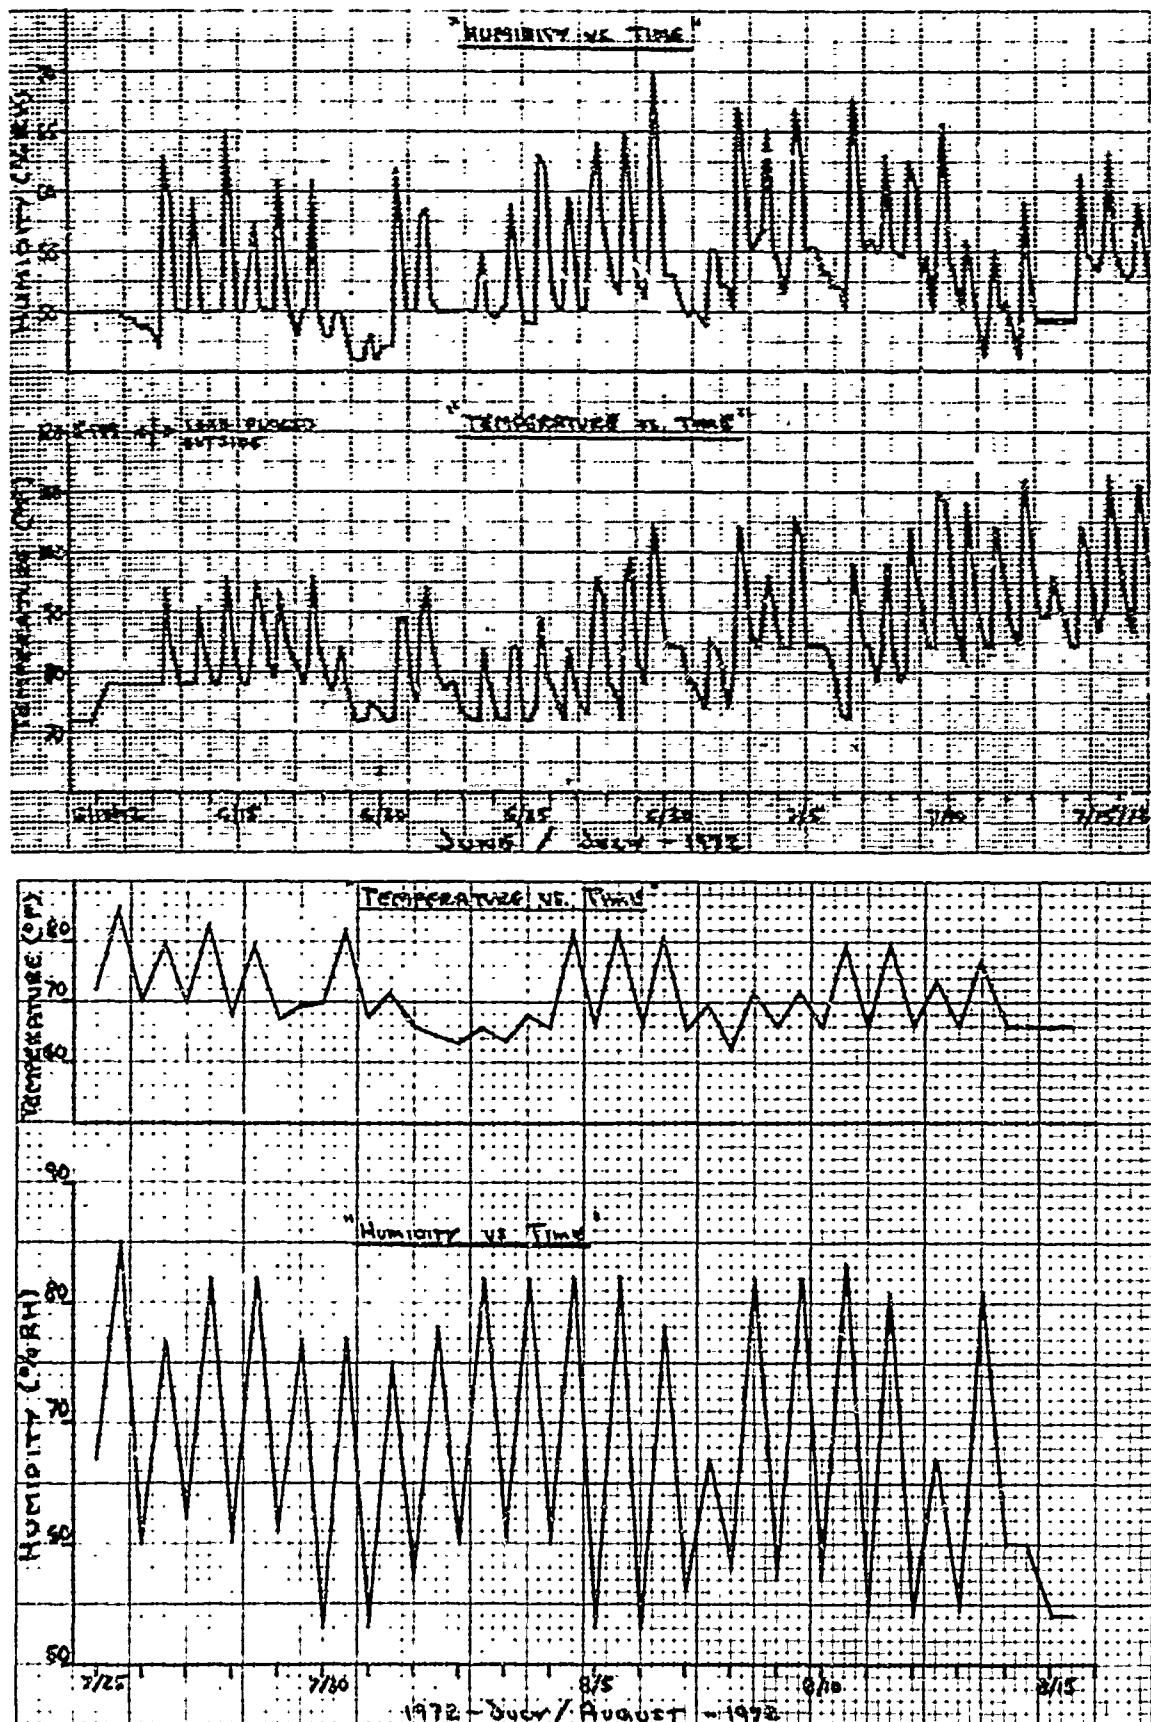
FIGURE 12

Temperature and humidity recordings taken inside a load which had been
 38
 conditioned at ambient room temperature prior to shrink wrapping.
